# Manhole Inspection Summary

Manhole # S31M1\_022MH

Insp Date: **2/8/08 1:34 PM**

**Location** Address: **2501 Seabury Road**

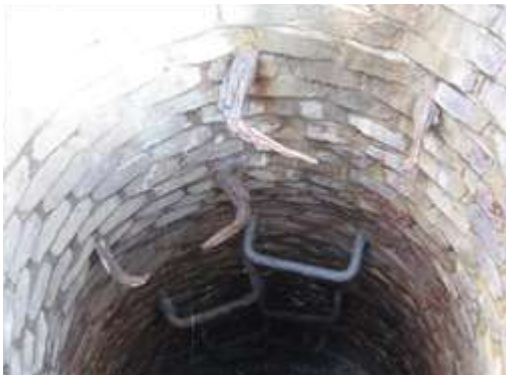
Defect 1

Count: **8** Missing: **2** ☒ **Corroded**

Steps

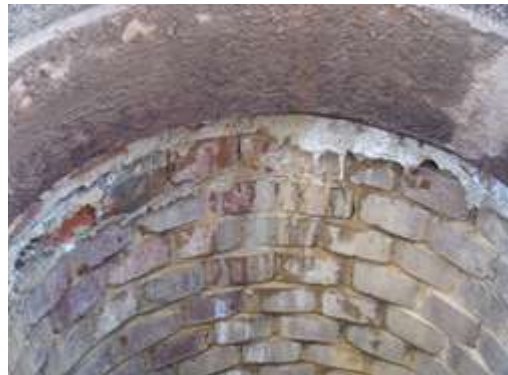
Defect 2

Infiltration: ☐ None ☒ **Joint** ☐ Cracks ☒ **Mortar** ☐ Roots ☐ Wall

Infiltration

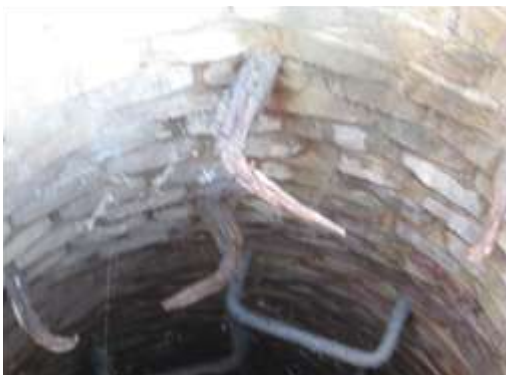
Steps

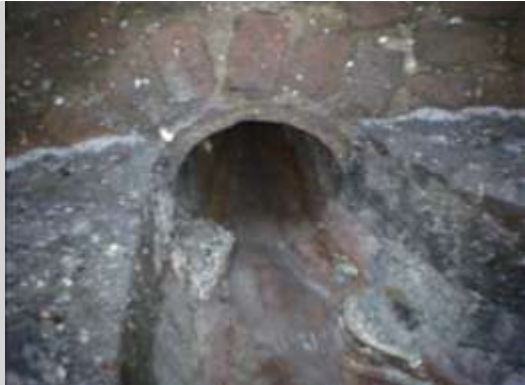
12 O'Clock Outflow

8 in. Circular Gravity Sewer  
Pipe Out @ 12 O'Clock

Pipe Height: **9.6** (in.) Rod and Bar (Angled)  
Pipe Material: **Clay** ☐ Pipe Lined  
Invert Depth: **13.01** (ft.) Flow Characteristics: **Fast**  
Deposits: ☒ None ☐ Mud ☐ Sludge ☐ Debris ☐ Grease  
Silt Depth: (in.) Deposits Extent:  
Infiltration: **None** Pipe Seal Cond: **Sound**

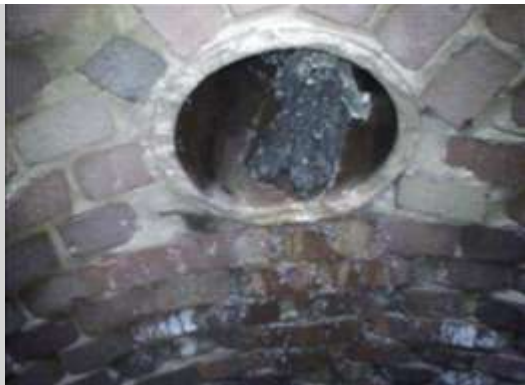
3 O'Clock Inflow

8 in. Circular Gravity Sewer  
Pipe In @ 3 O'Clock

Pipe Height: **9.6** (in.) Rod and Bar (Angled)  
Pipe Material: **Clay** ☐ Pipe Lined  
Invert Depth: **8.09** (ft.) Flow Characteristics: **Fast**  
Deposits: ☒ None ☐ Mud ☐ Sludge ☐ Debris ☐ Grease  
Silt Depth: (in.) Deposits Extent:  
Infiltration: **None** Pipe Seal Cond: **Sound**

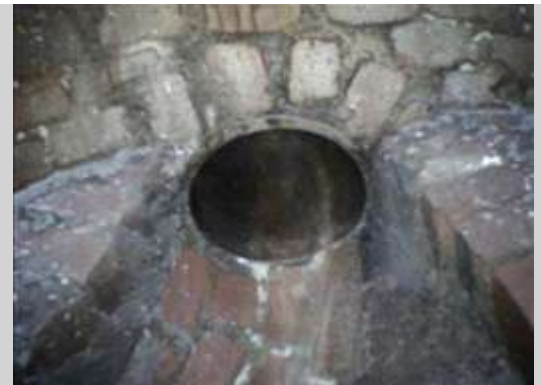
Drop In @ 3 O'Clock

Drop: **Outside** Rod and Bar  
Angled: **Yes** Reading: **12.27** (ft.)  
Inv Depth: **13.27** (ft.)  
Drop Condition: **Open**

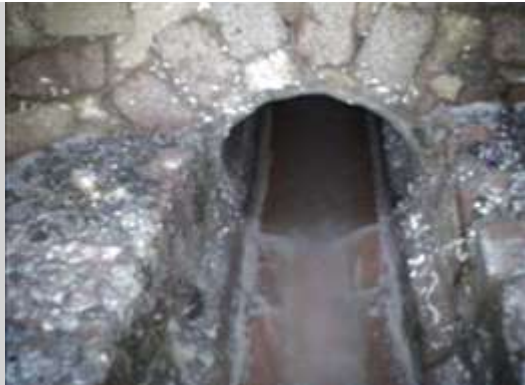
6 O'Clock Inflow

8 in. Circular Gravity Sewer  
Pipe In @ 6 O'Clock

Pipe Height: **9.6** (in.) Rod and Bar (Angled)

Invert Depth: **13.09** (ft.) Flow Characteristics: **Fast**

Infiltration: **None** Pipe Seal Cond: **Sound**
